# Manhole Inspection Summary

Manhole # S25G\_\_039MH

Insp Date: **3/31/08 10:23 AM**

**Location** Address: **13 W Fairmount AV**

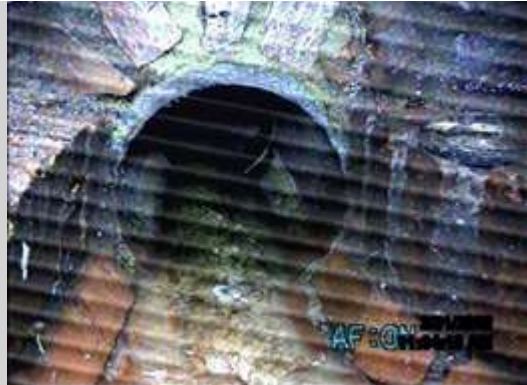
12 O'Clock Outflow

Pipe Height: **8.4** (in.) Rod and Bar (Angled)  
Pipe Material: **Clay** ☐ Pipe Lined  
Invert Depth: **7.77** (ft.) Flow Characteristics: **Slow**  
Deposits: ☒ None ☐ Mud ☐ Sludge ☐ Debris ☐ Grease  
Silt Depth: **0** (in.) Deposits Extent:  
Infiltration: **None** Pipe Seal Cond: **Sound**

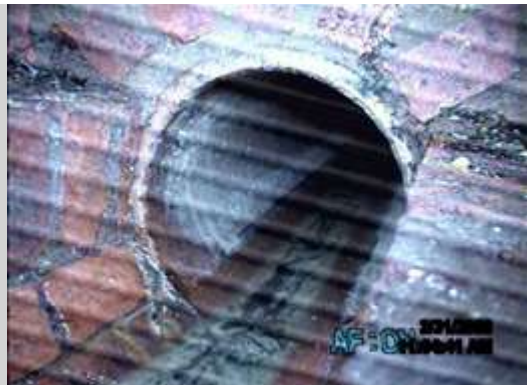
3 O'Clock Inflow

Pipe Height: **8.4** (in.) Rod and Bar (Angled)  
Pipe Material: **Clay** ☐ Pipe Lined  
Invert Depth: **7.80** (ft.) Flow Characteristics: **Slow**  
Deposits: ☒ None ☐ Mud ☐ Sludge ☐ Debris ☐ Grease  
Silt Depth: **0** (in.) Deposits Extent:  
Infiltration: **None** Pipe Seal Cond: **Sound**

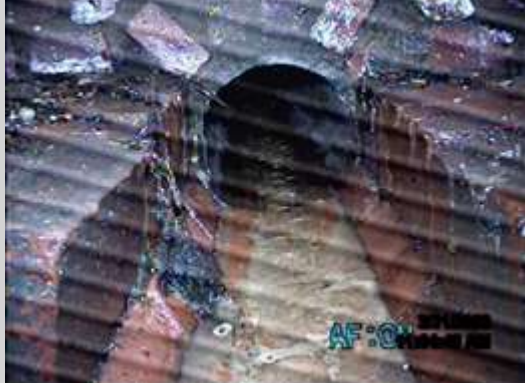
6 O'Clock Inflow

Infiltration: **None** Pipe Seal Cond: **Sound**
